Installation Instructions

LB81-23-032-02-02

2019+ Chevrolet Silverado

2019+ GMC Sierra

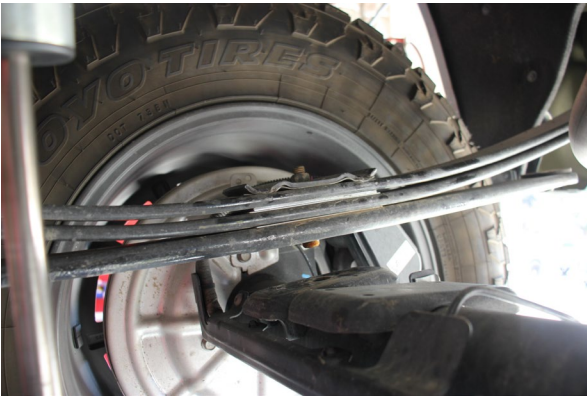
Lower the axle enough to install the Eibach lift block.

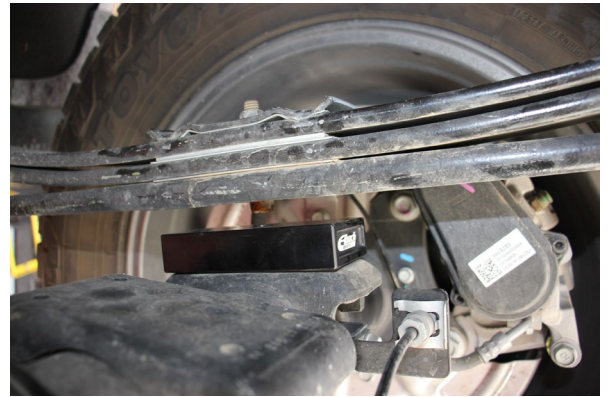
Install the Eibach lift block.

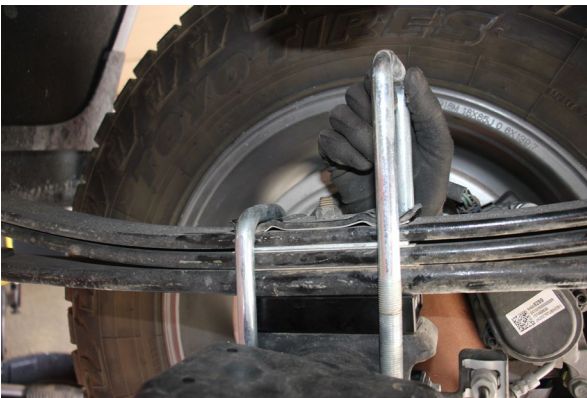
Raise the axle to seat the block to the leaf spring and install the u bolts.

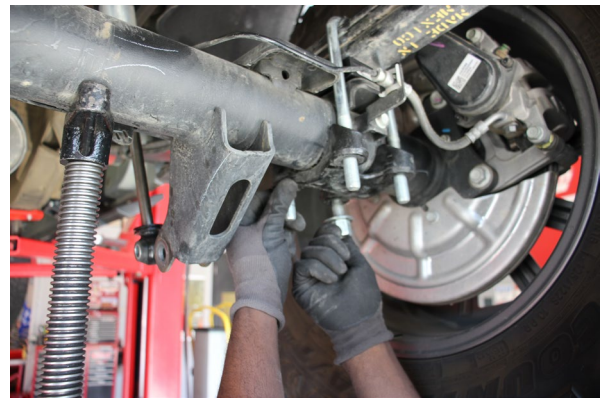
Install the provided washers and nuts and hand tighten so the u-bolts are showing equal amounts of threads at all sides.

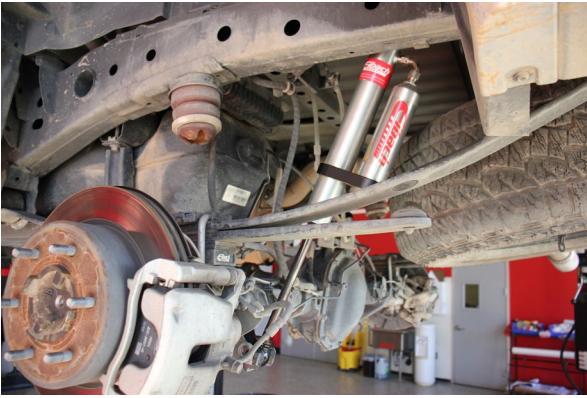
Remove the OE bump stop.

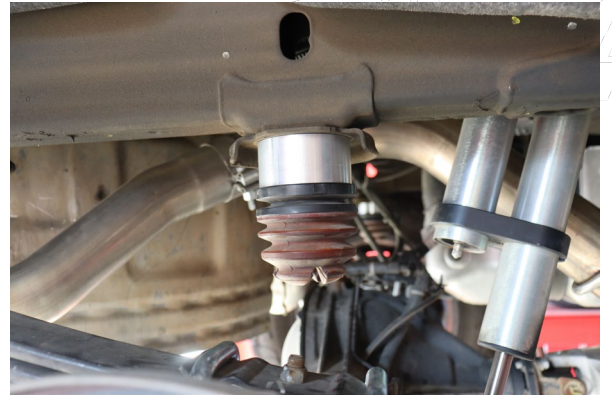
Reinstall with the provided bump stop spacer and bolt.
